# Tartan West Community Association

## Reserve Study Update - 2020

### **Executive Summary**

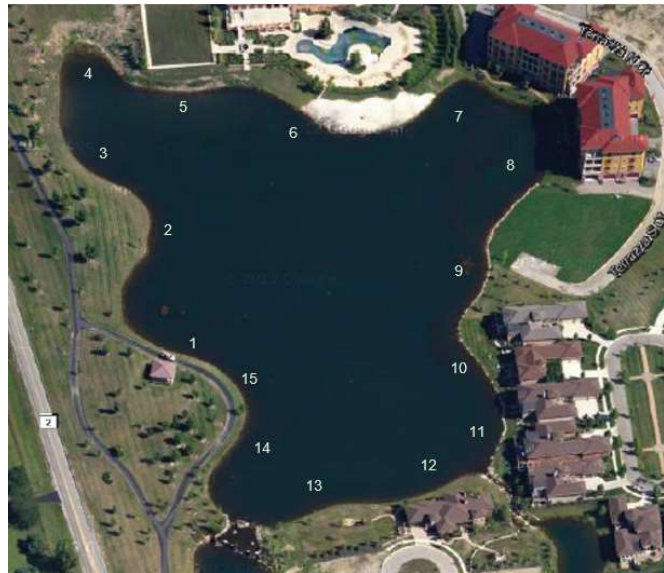
Largest Pond – near clubhouse

Sample#	Water Depth in feet	Sludge Depth in inches
1	8	3
2	8	5
3	6.5	2
4	5	21
5	5	4
6	5	12
7	9	24
8	7	8
9	5	4
10	5.5	12
11	9	3
12	7	4
13	6.5	5
14	5.5	18
15	5	12

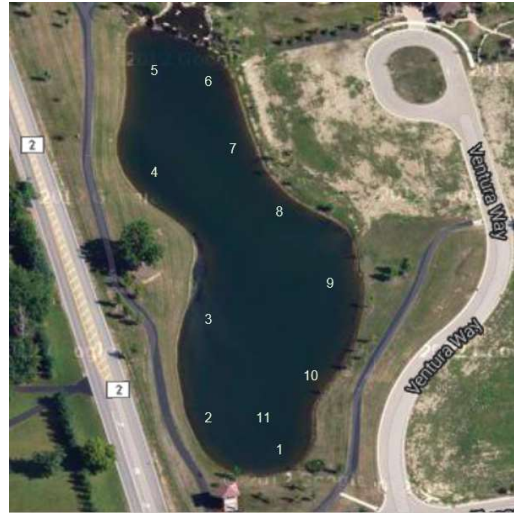
Pond – just south of largest pond

Sample#	Water Depth in feet	Sludge Depth in inches
1	6.25	4
2	7	2
3	6	2
4	6.75	6
5	8	< 1
6	7	< 1
7	7.5	< 1
8	6	4
9	9	5
10	9	3
11	9.5	< 1

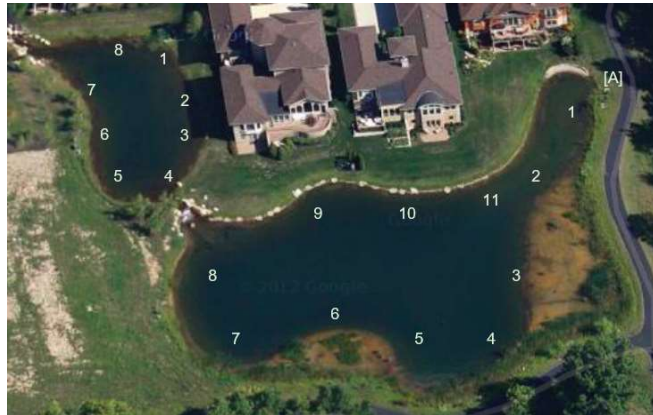
Ponds – east of Ventura Way Circle

**Upper Pond:**

Sample#	Water Depth in feet	Sludge Depth in inches
1	3.5	5
2	4	3
3	3.5	3
4	4.5	2
5	5	12
6	6	2
7	5	24
8	5	24

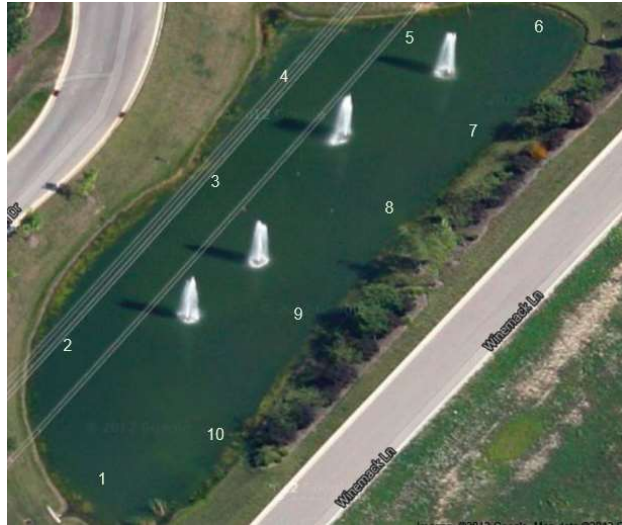
Pond – at intersection of Vineyard Haven Dr and Winemack Ln

Sample#	Water Depth in feet	Sludge Depth in inches
1	3	12
2	4	6
3	4.5	8
4	3	12
5	4	4
6	5	12
7	3.5	8
8	3.75	4
9	3.75	6
10	4	6

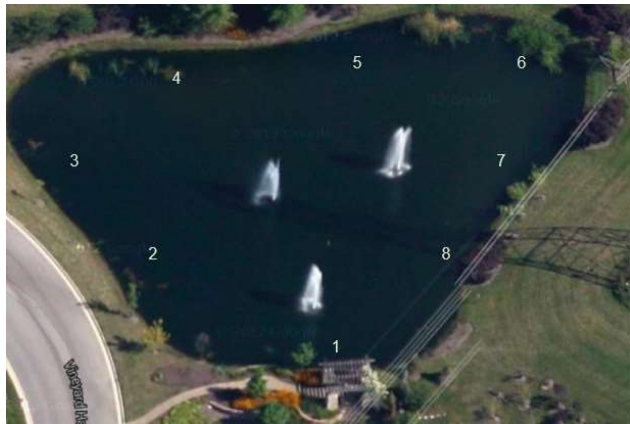
Pond – NE of Vineyard Haven Dr at stone pergola

Sample#	Water Depth in feet	Sludge Depth in inches
1	4	4
2	4	8
3	5	6
4	5	4
5	4.5	6
6	2	12
7	3.5	4
8	3	2

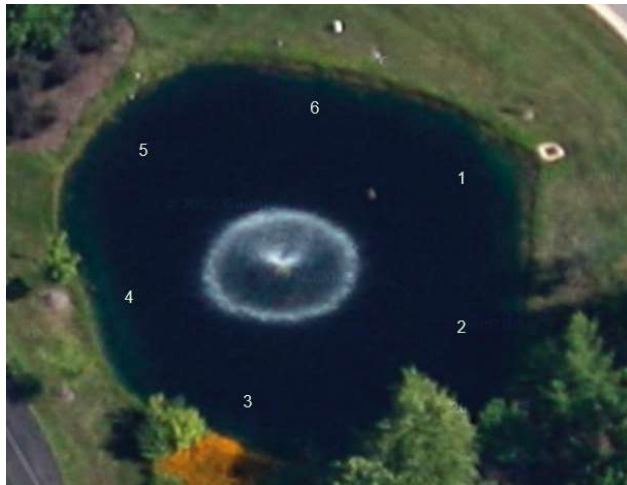
Pond – at Corazon & Vineyard Haven

Sample#	Water Depth in feet	Sludge Depth in inches
1	4	6
2	5	7
3	4	5
4	3	6
5	2.5	5
6	3	2
