RESERVE FUND STUDY

**TARTAN WEST COMMUNITY ASSOCIATION
7195 TUSCANY DR
DUBLIN, OHIO 43016-6131**

**Criterium Liszkay Engineers
1075 Beecher Crossing N, Suite D
Gahanna, OH 43230
614-418-7200
www.criteriumliszkay.com**

*Final - Revision 0
March 26, 2026*

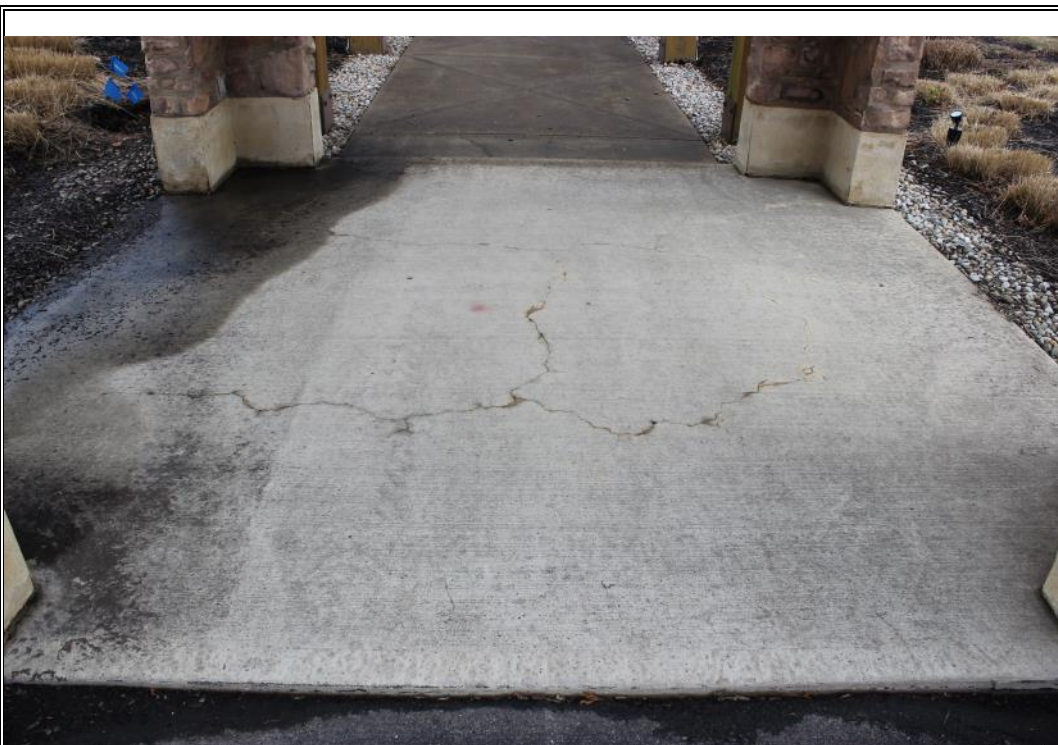
The concrete surfaces were cracked in some locations, and standing water was observed on select areas.

Cracked concrete and standing water on the concrete surface.

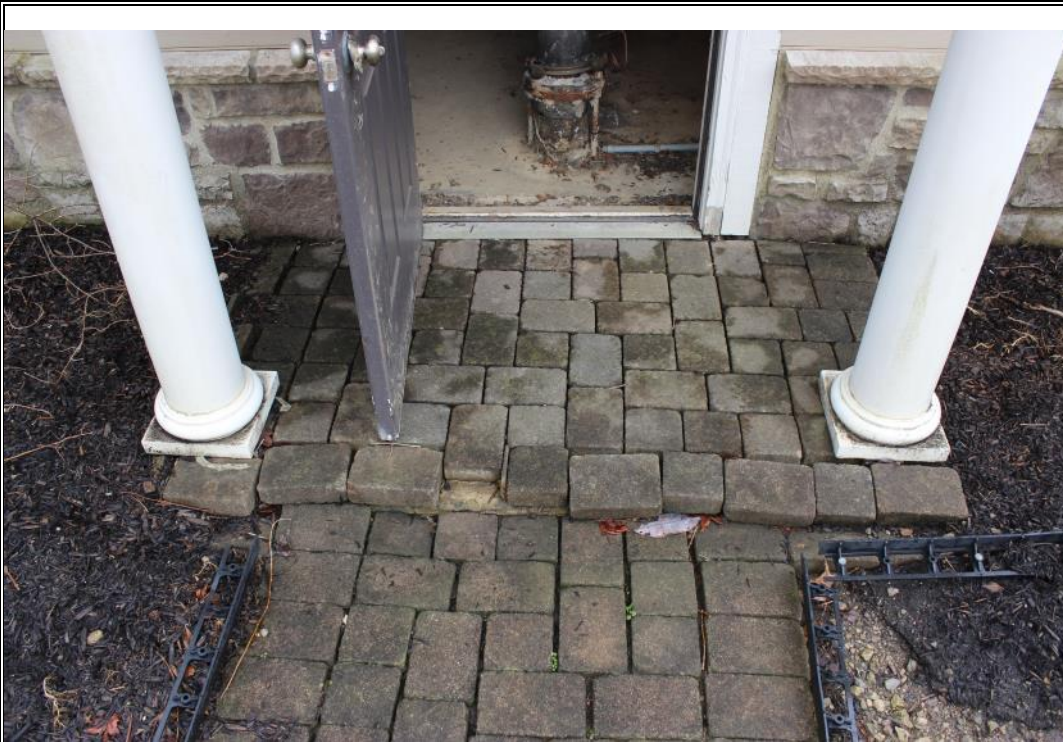
Photo Number
5

The pavers are reaching the end of their useful life. Present repairs are required, and full replacement will be required during this study period.

Description:
Deteriorated
pavers and
settlement at the
pond #6 pump
house.

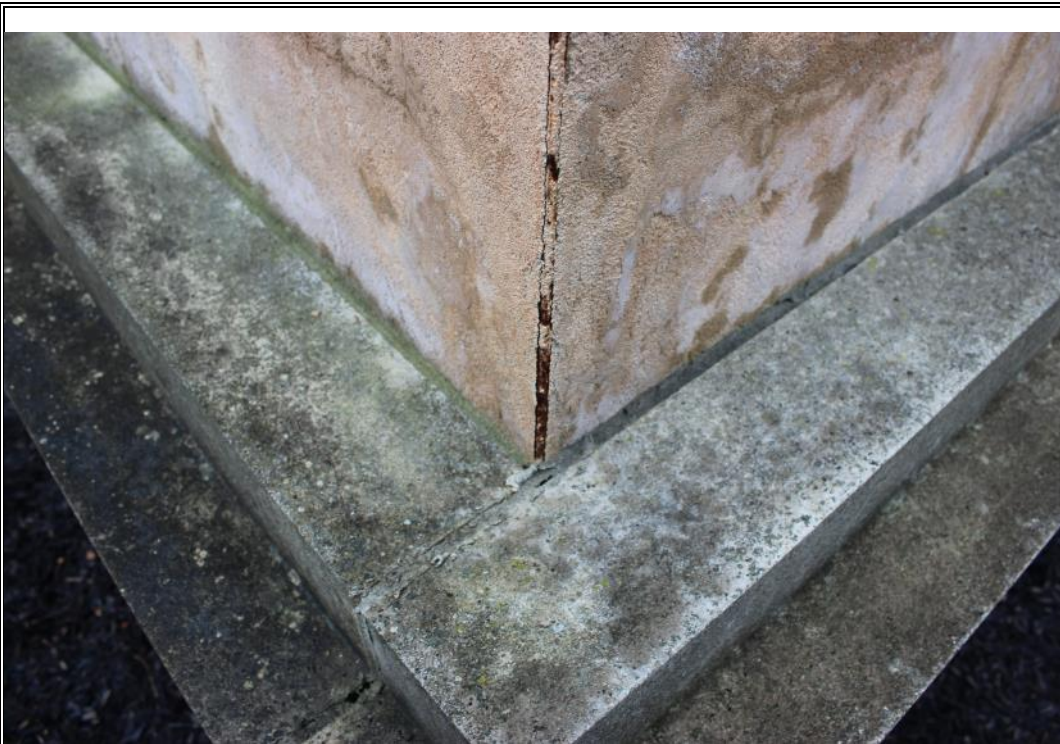
Photo Number
7

The masonry sign monuments exhibited corrosion at the stucco corner beads, failed joints between stones, and mulch piled too high up the masonry stone veneer walls. It is recommended to repair these issues soon to prevent further deterioration of these structures from moisture damage. We also recommend that the monuments be regularly powerwashed. If not maintained, replacing these structures is relatively expensive.

Description:
Two areas of deterioration observed on most monuments included corroding stucco corner beads and failed stone joint sealant/mortar.

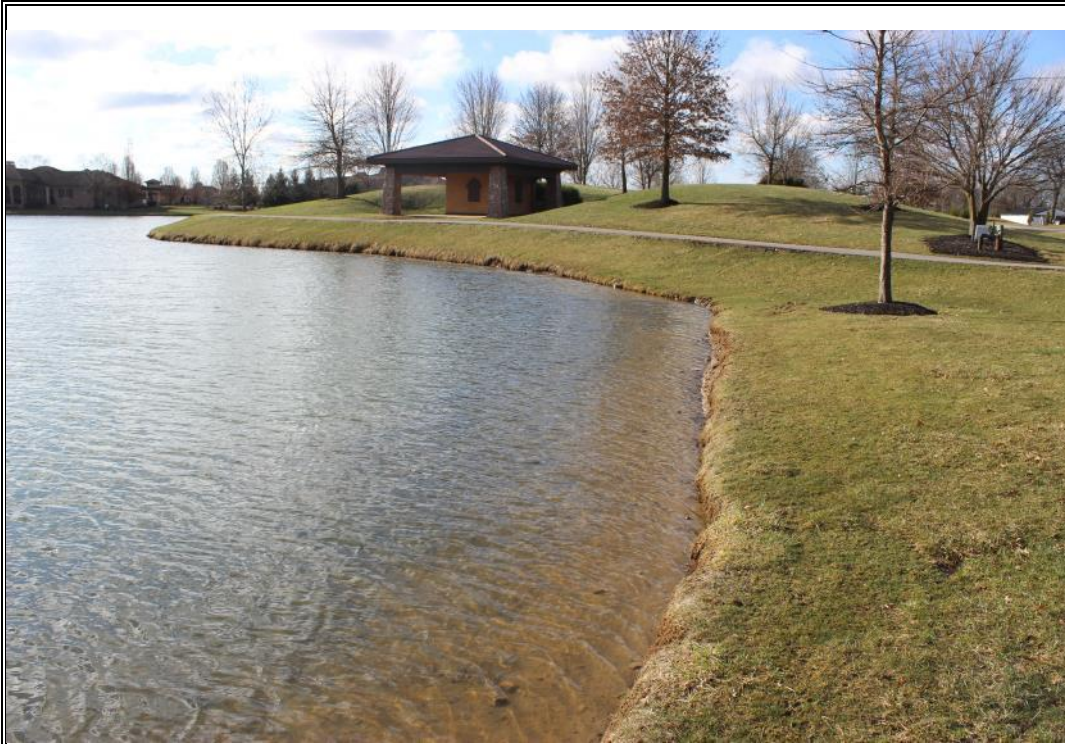
Photo Number
9

Pond #1 – This is the largest pond. Erosion of the edge was observed, especially on the north and west. Vegetation was present around some of the perimeter. The erosion around this pond is by magnitude the worst of the ponds. Plans to control this erosion in the short term should be implemented.

Description:
Eroding west edge
of pond #1. Note
the pump house.

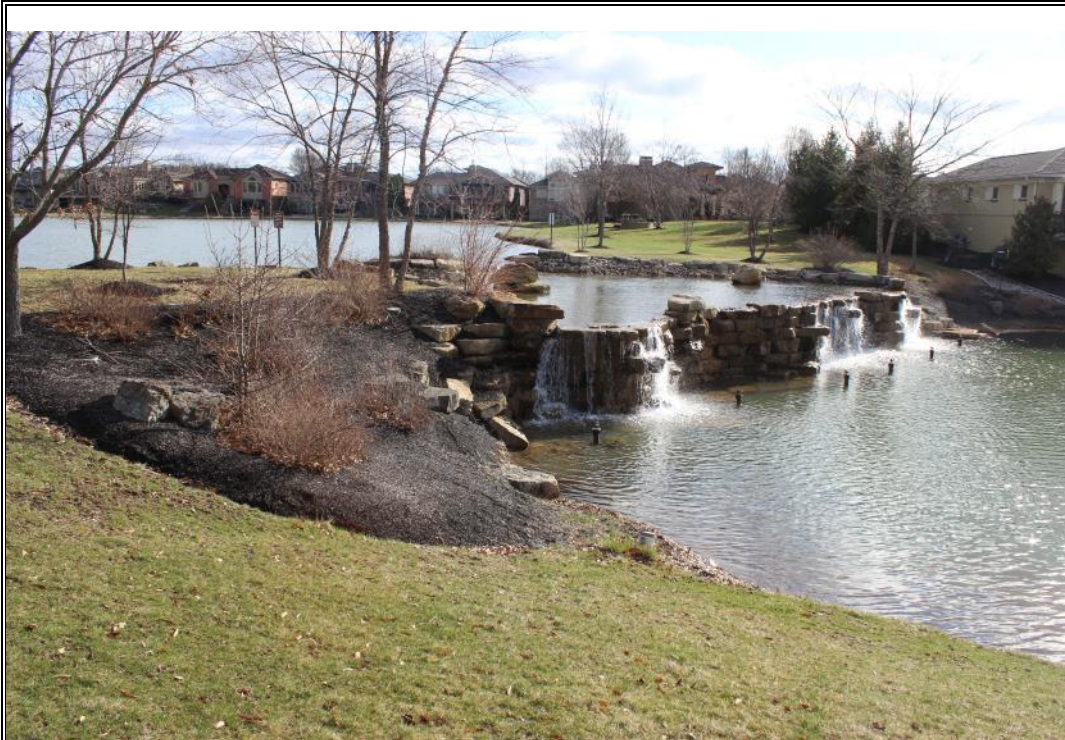
Photo Number
10

Some deterioration was observed of the waterfall structure between ponds #1 and #2. Periodic repairs to these waterfalls should be made to prolong their useful life.

Description:
Waterfall between
ponds #1 and #2.

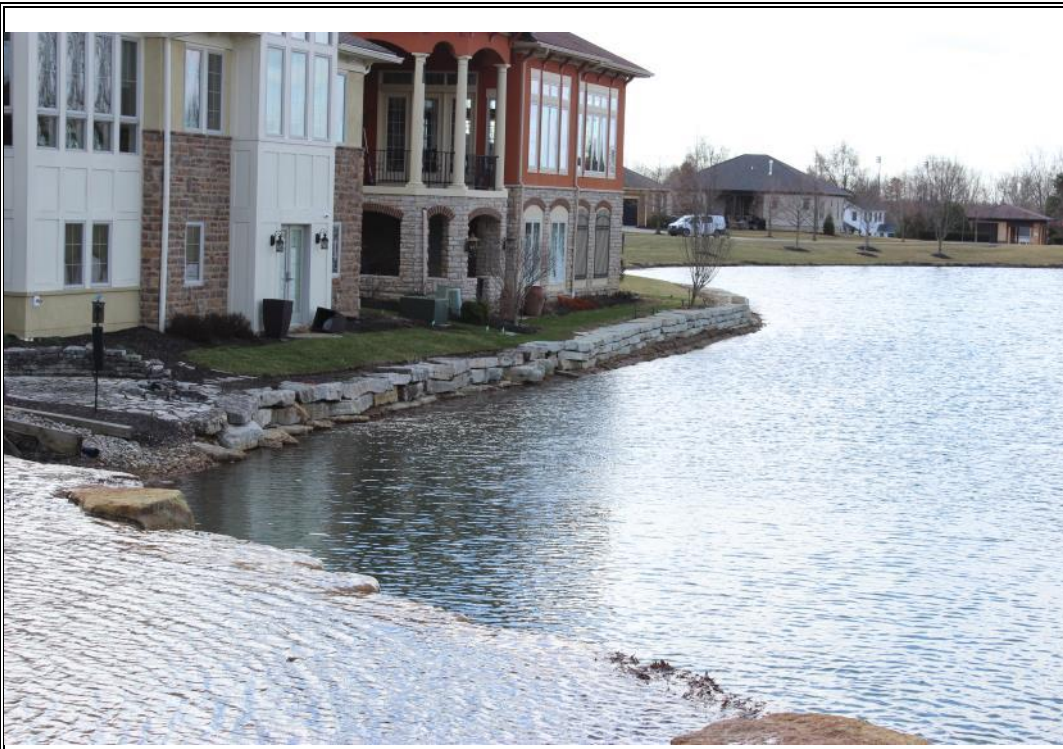
Photo Number
11

Pond #2 - The pond surface was partially frozen over at the time of the inspection. Some stone edge rip-rap was present on the south end of the pond. It was reported by the board that this stone was installed due to edge erosion. Erosion of the edge was observed in other areas of the pond.

Description:
Some stone edging
along the east bank
of pond #2.

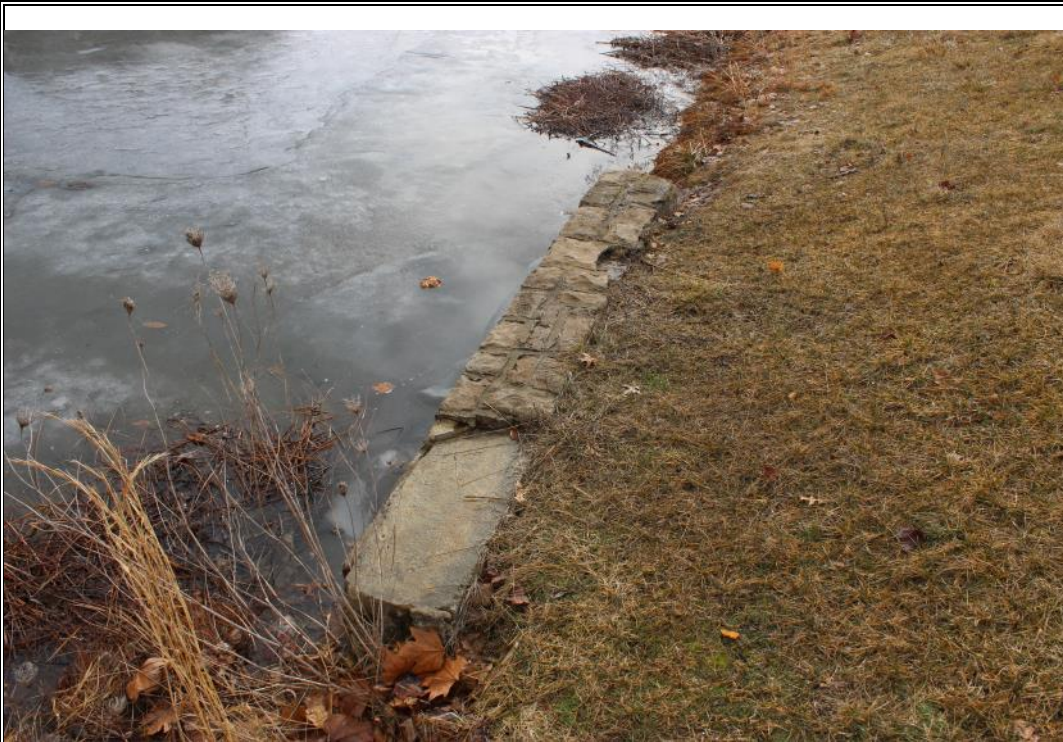
Photo Number
13

Pond #4 - The pond surface was frozen over at the time of the inspection. The edges of this pond are eroding. The stone veneer on the headwalls is failing in some areas and should be repaired. Some cleanup of debris and vegetation is needed around this area. Vegetation was present around some of the perimeter. It should be decided if vegetation is the preferred edge erosion control method, and formally installed around the entire perimeter.

Description:
Failing stone
veneer at a
headwall at pond
#4.

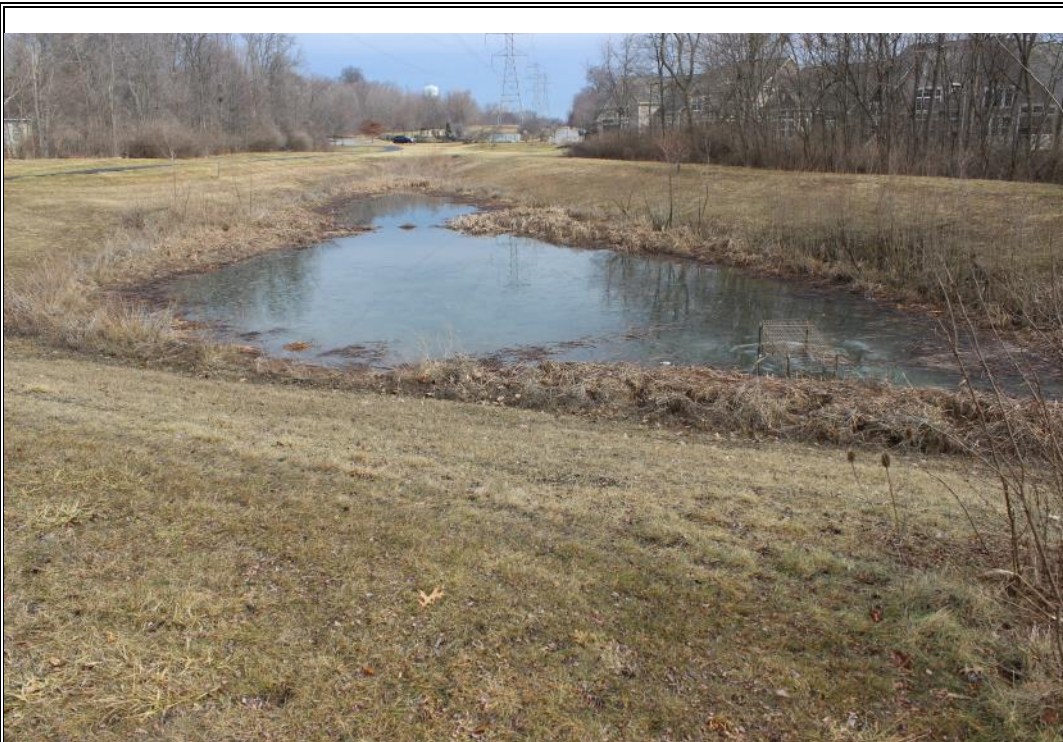
Photo Number
14

Wetland #5 – Some cleanup of debris and vegetation is needed around this area. The stone veneer on the headwalls is failing in some areas and should be repaired. Note that the Stone

Description:
Wetland #5.

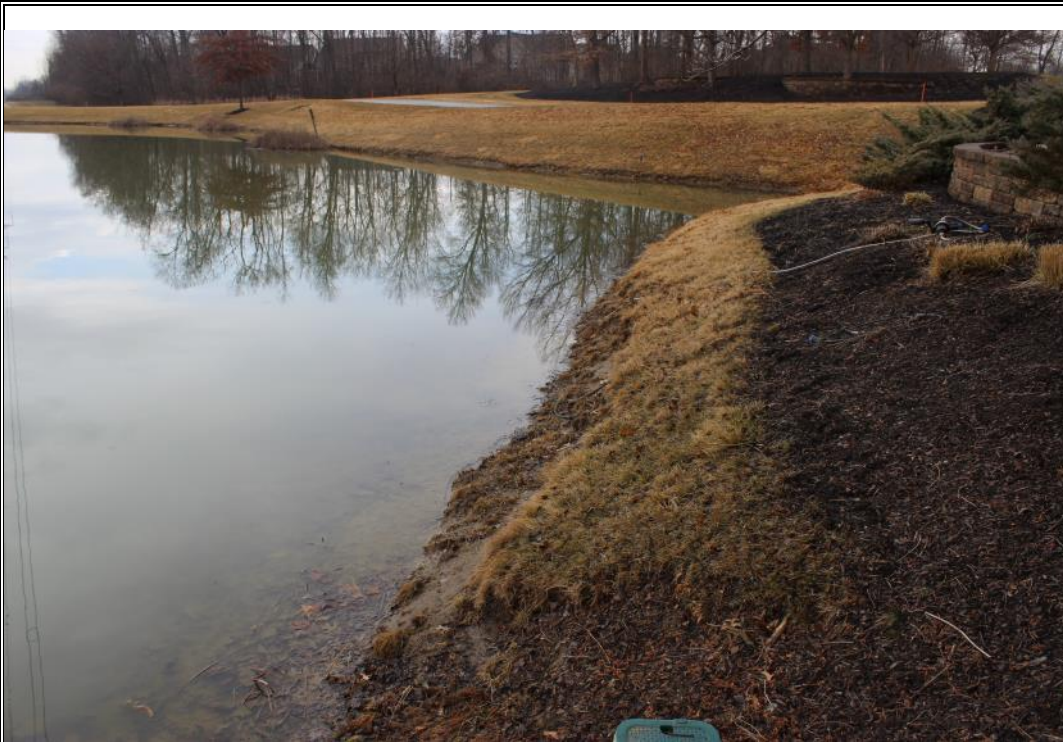
Photo Number
17

Description:
Eroding edge of
pond #8

It was reported by the board that some of the pond edge erosion may be being caused by muskrat activity. We have included funds for additional pond edge repair.

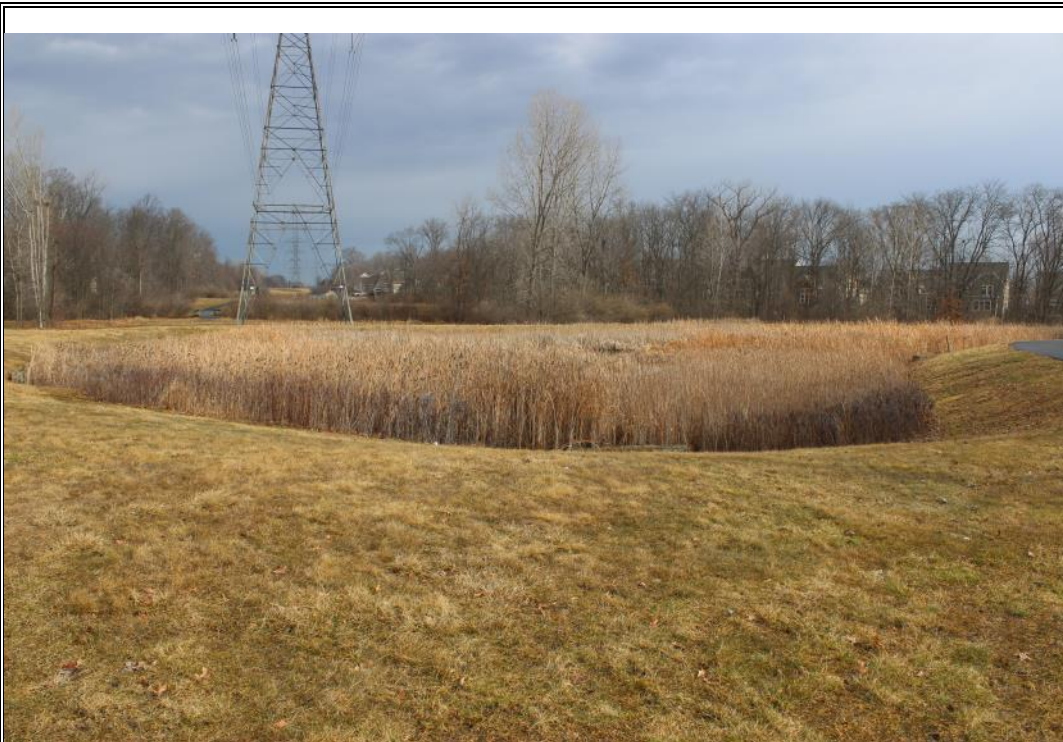
Photo Number
18

Wetland #9 - Was mostly filled with cattails and other wetland vegetation. The board reported there have been occasions in the past when the pond emits a foul odor and that very little has been done with this pond over the years. In their December 1, 2021 report, Stone Environmental defines this pond as a "wetland", and recommends among other things, to "Investigate design implications to convert Pond 9 (wetland design) to a pond. We recommend that a civil engineer be consulted to further explore this conversion to a true pond if the plant growth and odor are a concern. The stone veneer on the headwalls should be powerwashed, tuck-pointed and sealed with a siloxane based sealant.

Description:
Vegetation in
wetland #9.

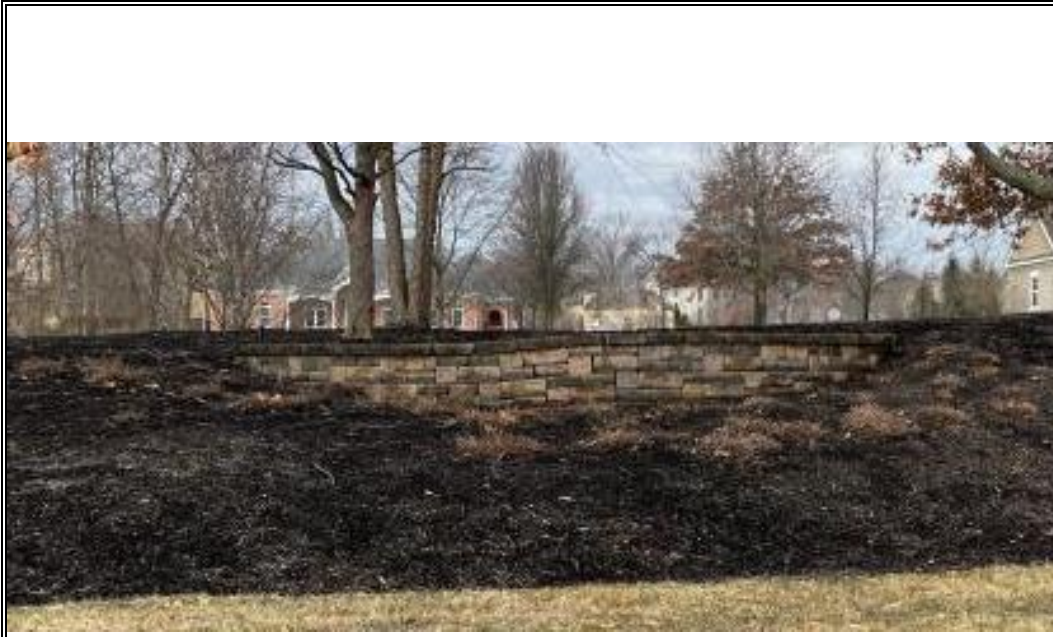
Photo Number
19

Description:
Signs of settlement at the stacked stone retaining wall on the south side of pond #6.

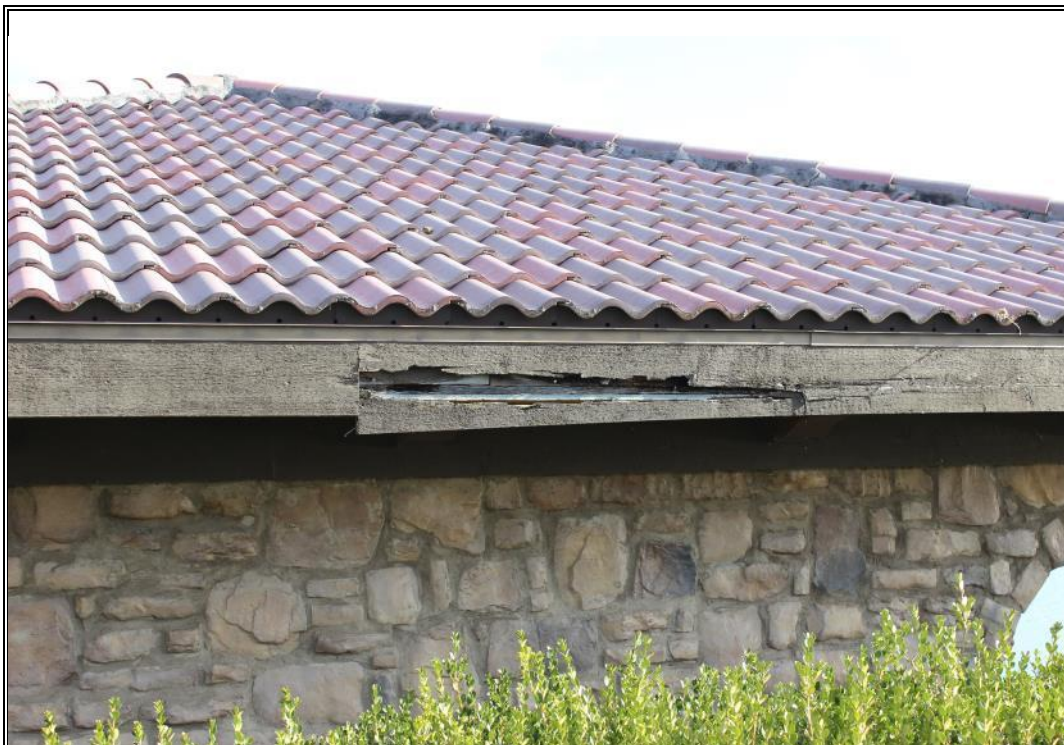
Photo Number
22

The wood trim and wood on all of the structures and pergolas is in need of repairs and recoating at this time.

Description:
The pump house
clay tile roof. Note
the deteriorated
wood fascia board.

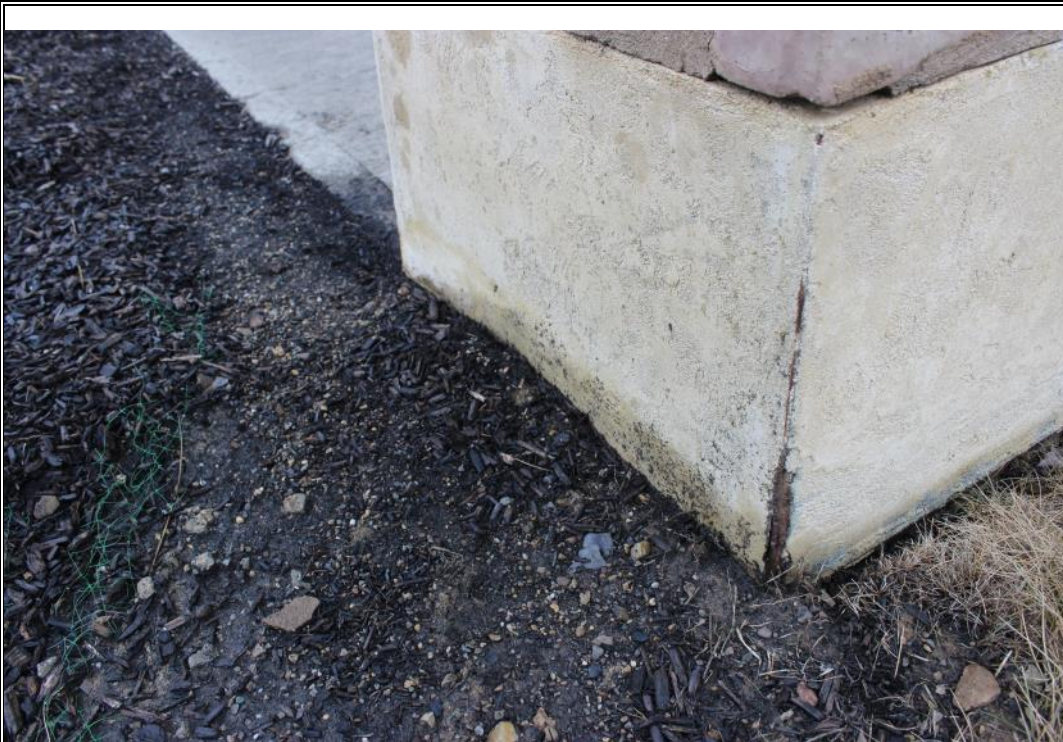
Photo Number
23

Description:
Stucco which runs too close to the ground likely causing moisture damage and corroding corner beads.

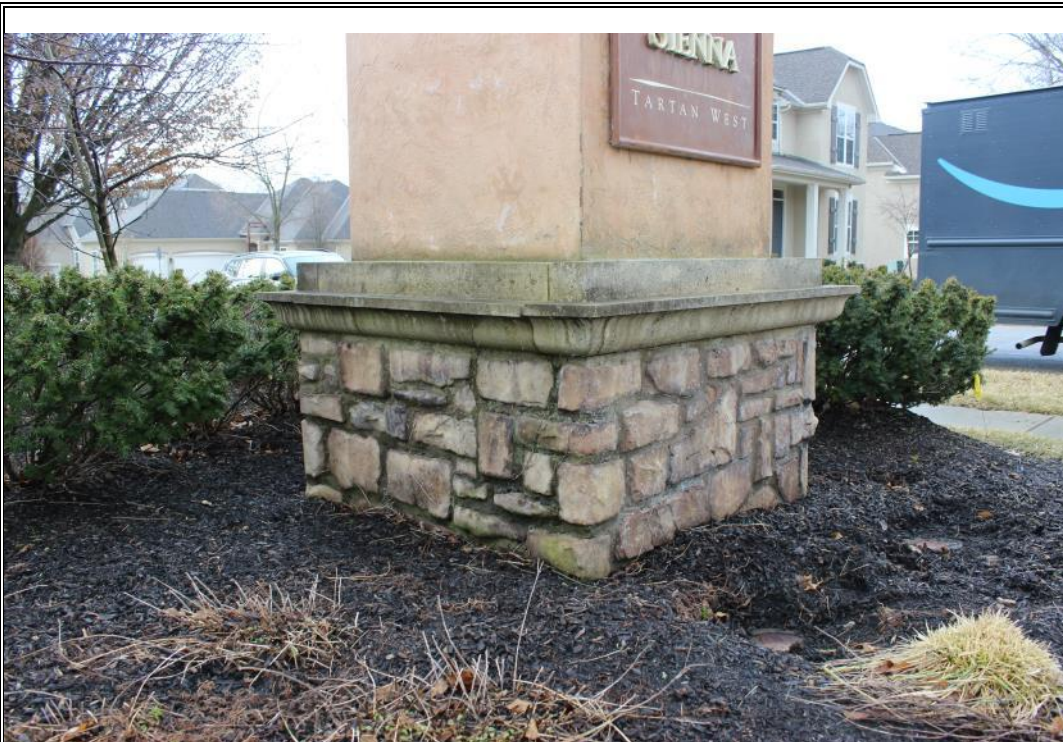
Photo Number
24

Description:
A masonry monument in need of powerwashing and sealing.

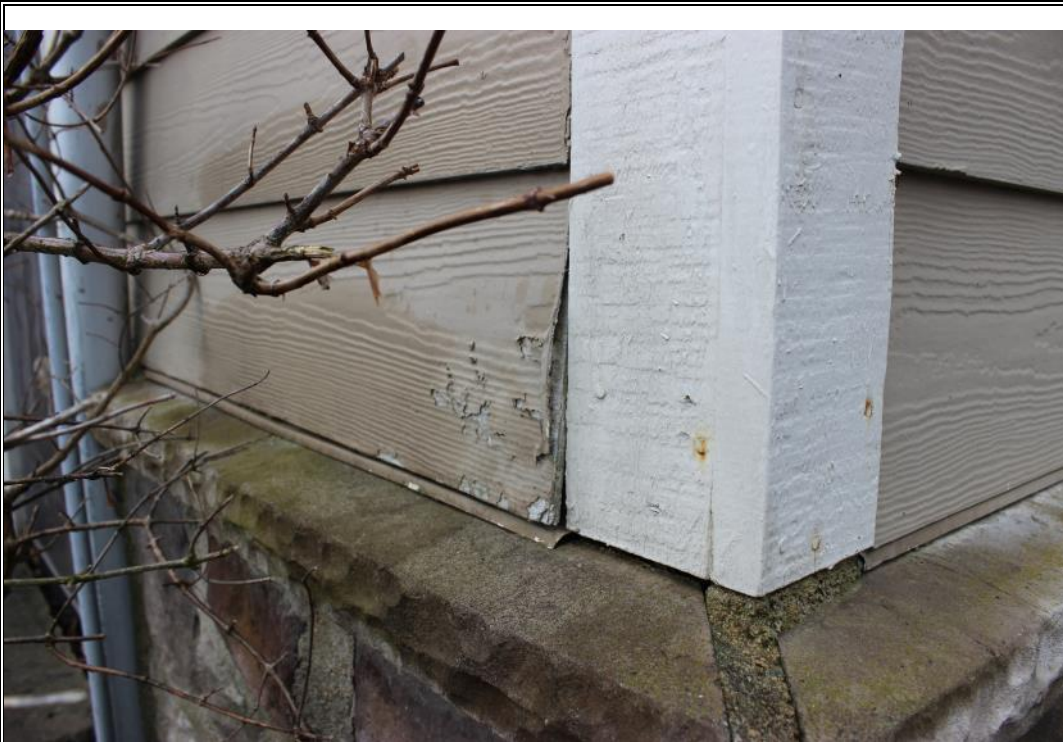
Photo Number
25

The following issues were observed on the exterior of the pump house next to pond #6 and should be corrected as soon as possible:

1. Deteriorated hardware on the doors
2. A damaged window insulated glass unit
3. Deteriorated engineering siding in select locations
4. Mulch piled in contact with the masonry stone veneer

Description:
Deteriorated
engineered
siding
on the pump
house.

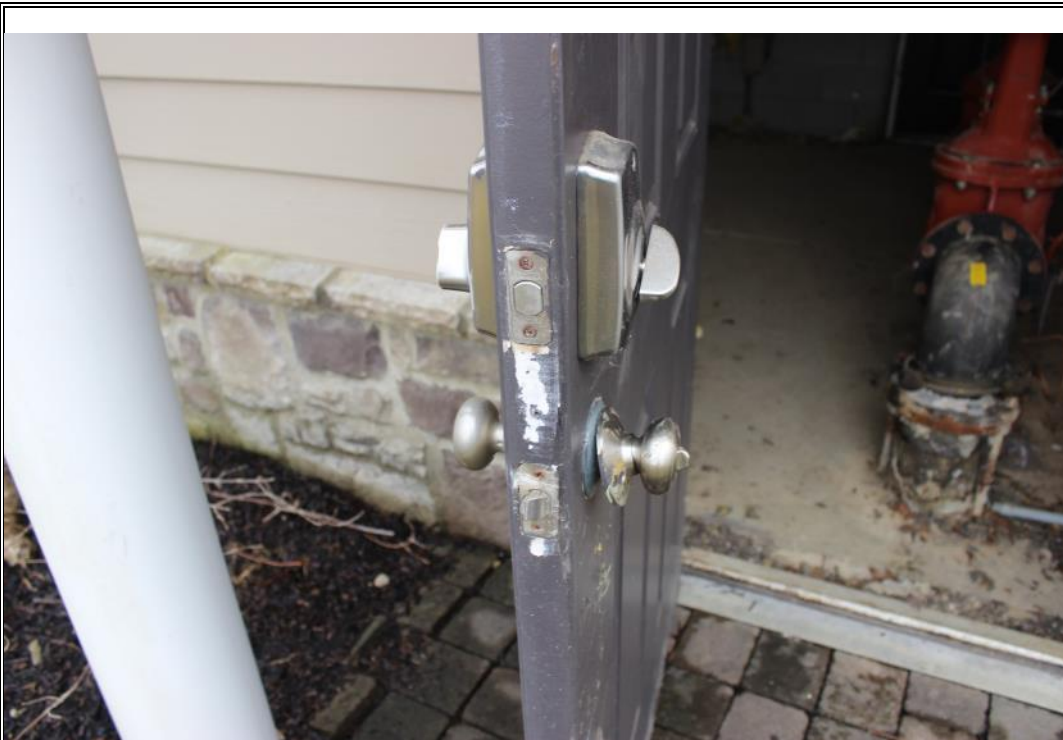
Photo Number
26

5. Corroding fasteners on the trim boards
6. Doors in need of re-coating
7. Worn and corroded wall light fixtures

Description:
A deteriorated
door and door
hardware on the
pump house.

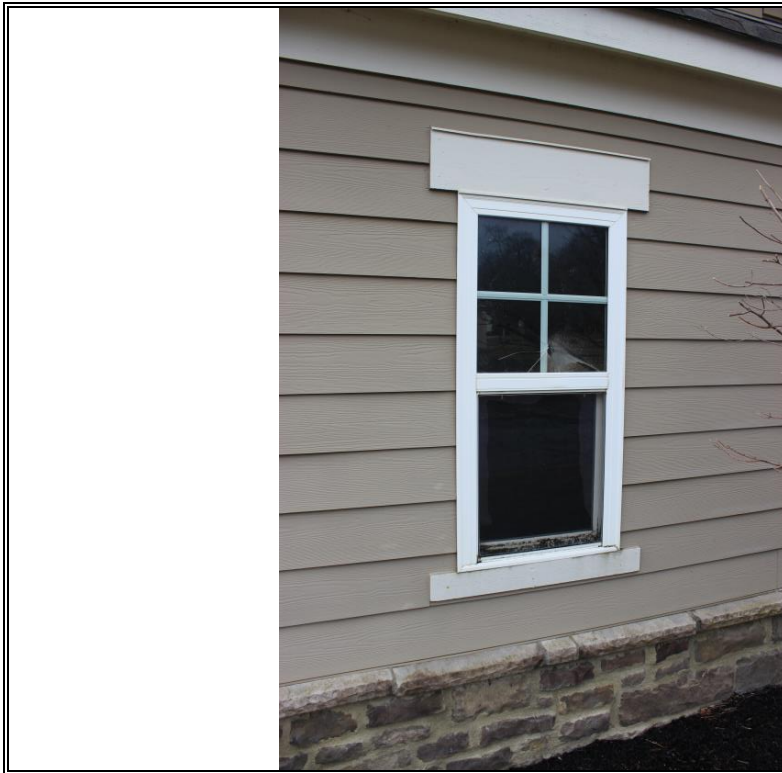
27

A damaged window on the pump house. Note the mulch piled above the base of the masonry stone veneer.

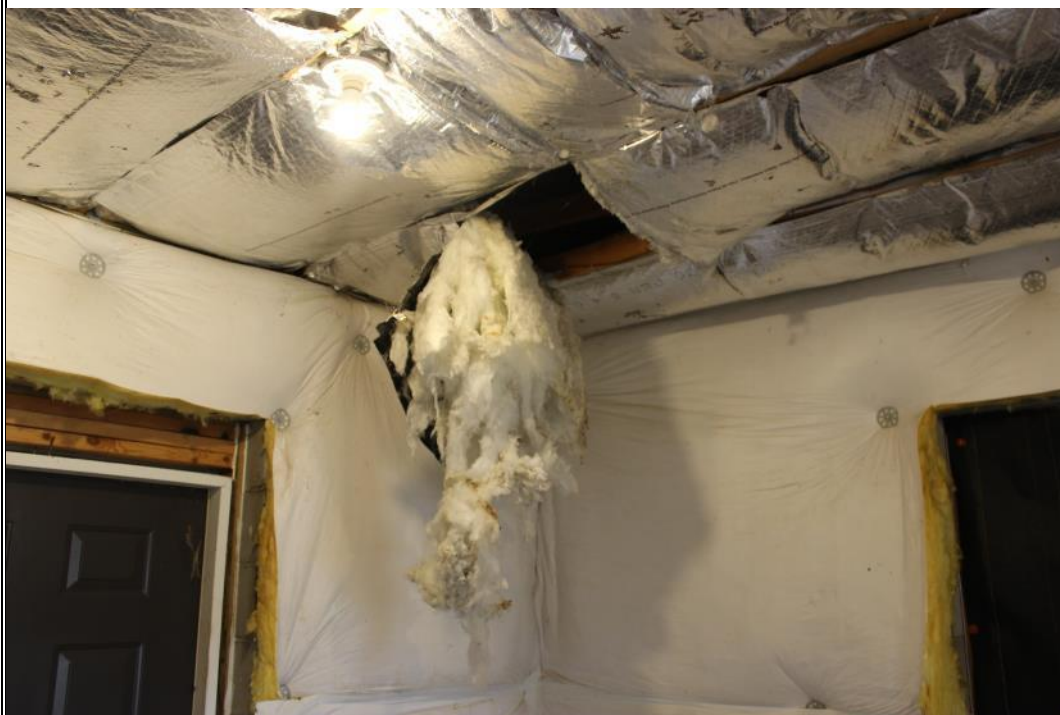
The following issues were observed on the interior of the pump house next to pond #6 and should be corrected as soon as possible:

1. Evidence of mice activity including damage to the insulation and contamination of equipment with mice waste.
2. Holes/gaps in the exterior façade
3. Falling and missing attic insulation
4. Wood posts being used to support piping equipment, where specialty steel pipe supports should be being used.
5. Danger Red Tags on some of the equipment
6. Excessive debris on the floor

The interior of the pond #6 pump house. Note the failing ceiling insulation.

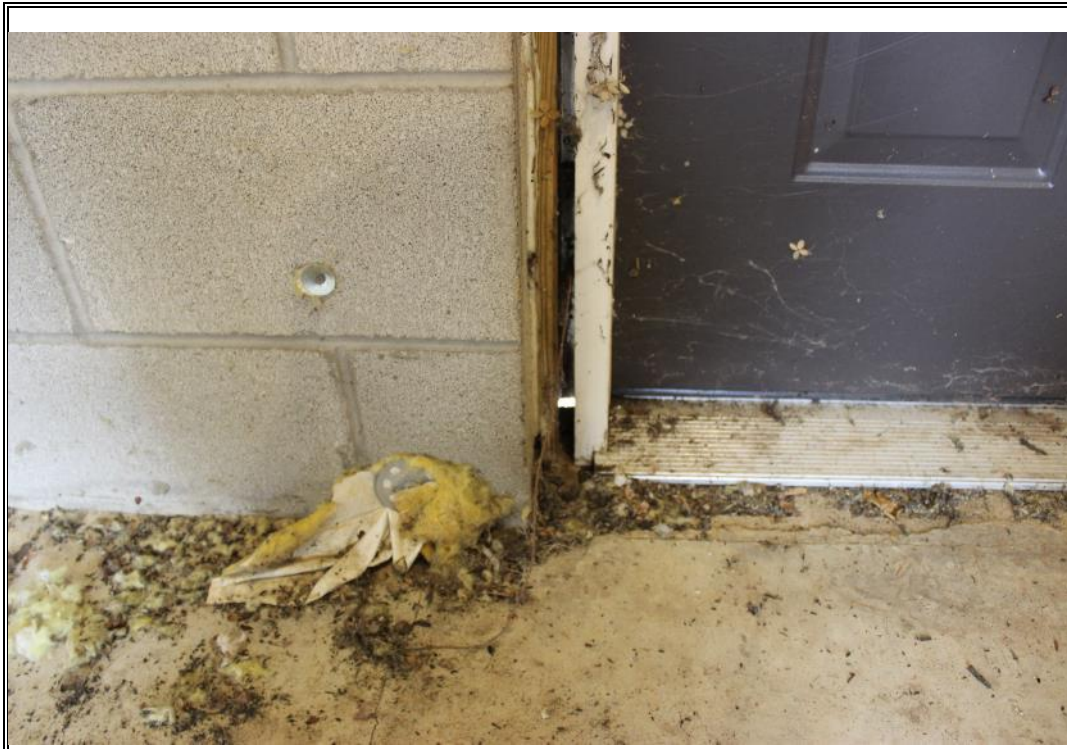
Photo Number
29

Description:
The interior of the pond #6 pump house. Note gap to the outside, missing wall insulation and evidence of mice.

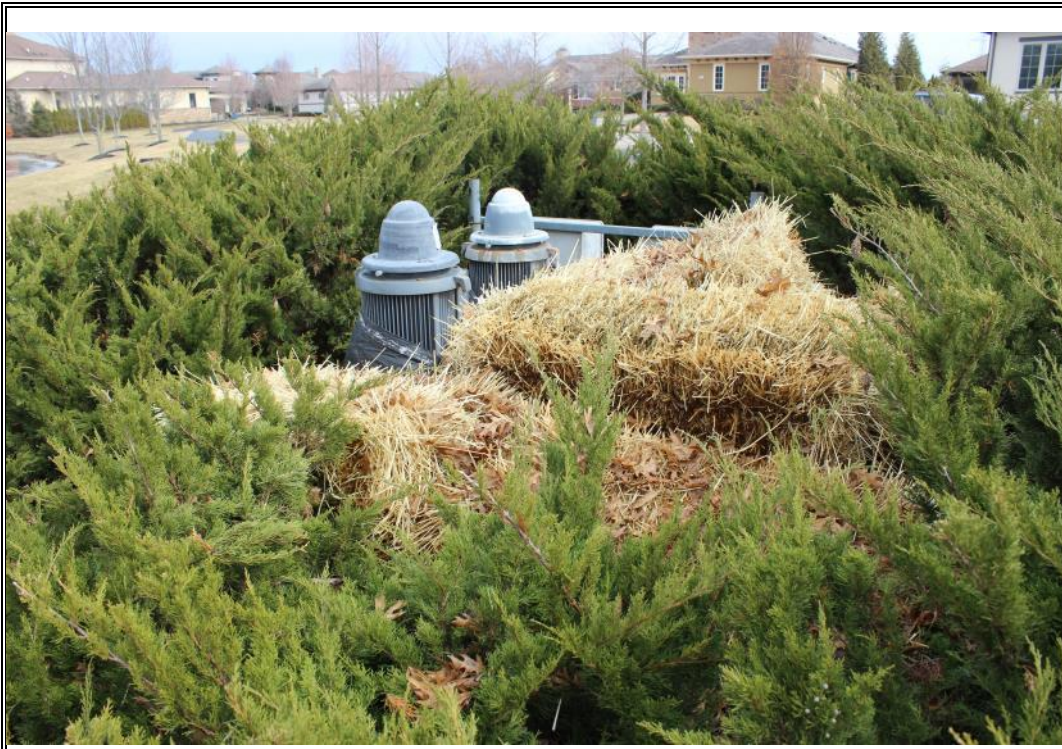
Photo Number
45

The pumps at the southeast corner of pond #2 are being protected from freezing by hay bales and tarps. Additionally, these pumps are not readily accessible for inspection or repairs due to overgrown vegetation. We recommend that consideration be given to installing a heated structure over these pumps so that they are protected from freezing and easily accessible for repairs and inspection.

Description:
Pond pumps near
the south end of
pond #2.

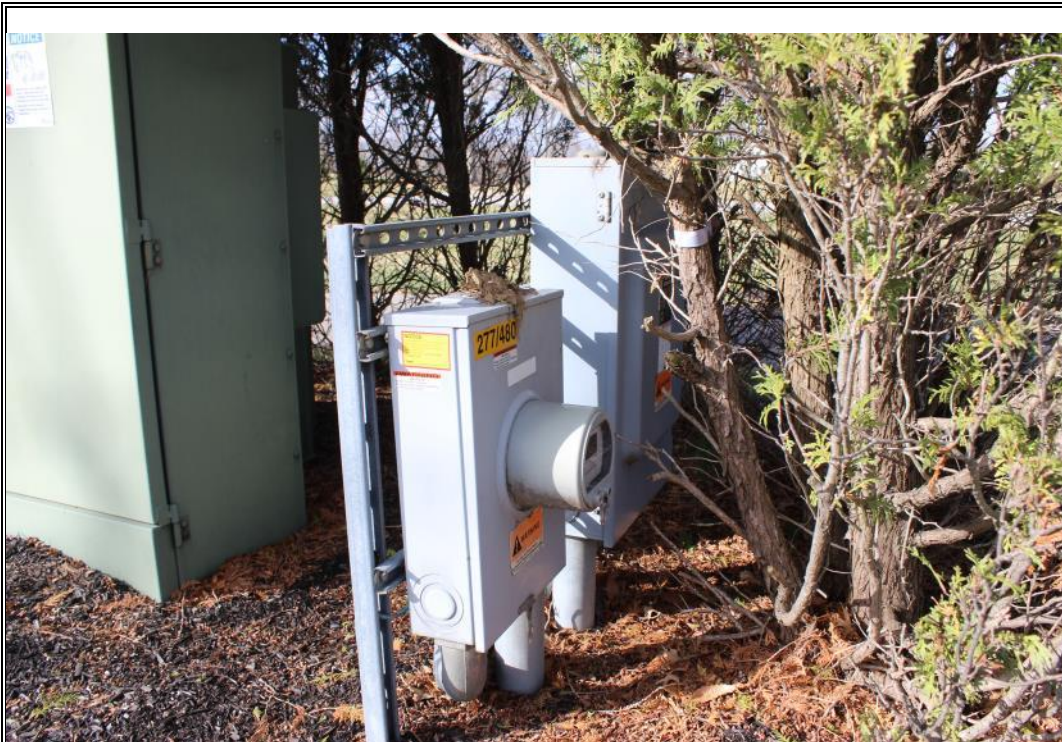
Photo Number
46

Description:
An electrical panel
not easily
accessible and
without proper
clearance on the
west side of ponds
#1/2.

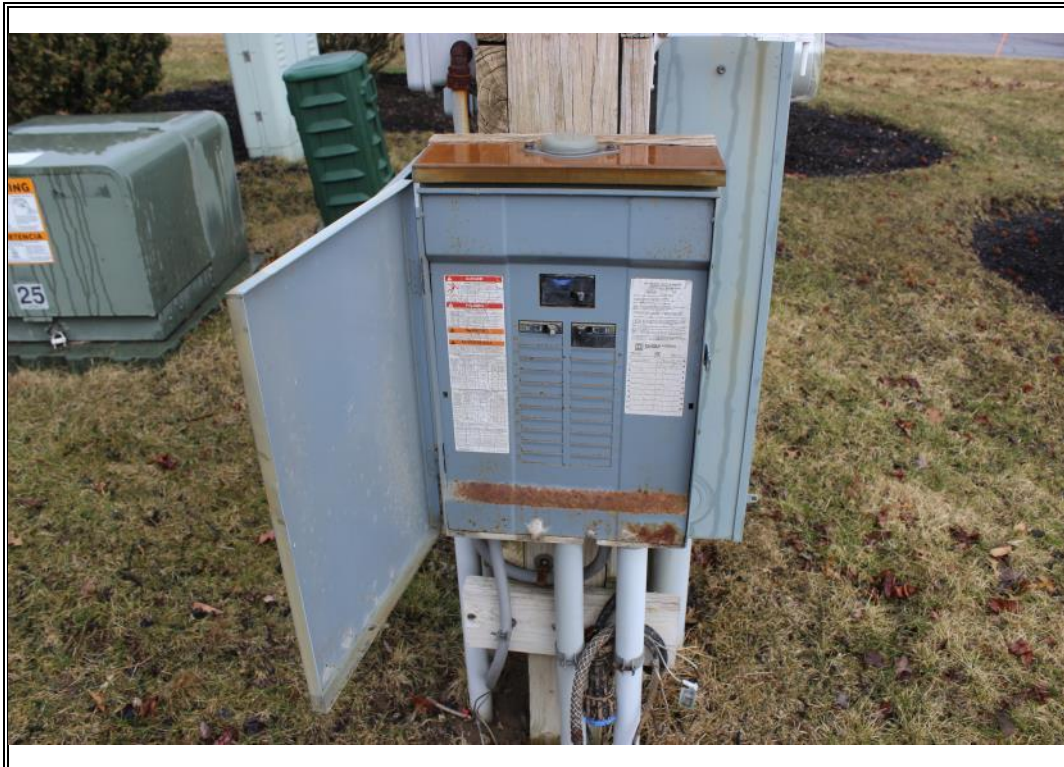
Photo Number
48

Some corroded metal electrical boxes were observed.

Description:
A corroded
electrical breaker
panel at pond #6.

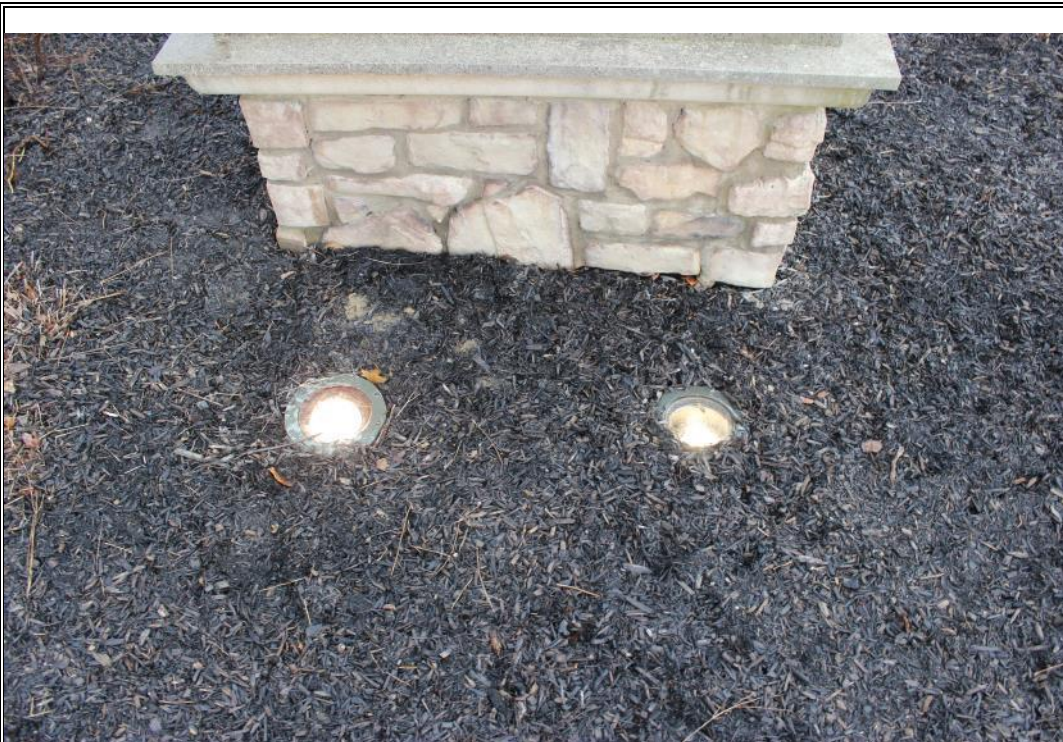
Photo Number
50

Description:
Typical landscaping lights at the monuments. Several of these were found to be covered with mulch.

It is recommended that a regular maintenance item be completed to ensure the below grade landscaping lights, irrigation boxes, and electrical boxes be cleared of all debris and vegetation.

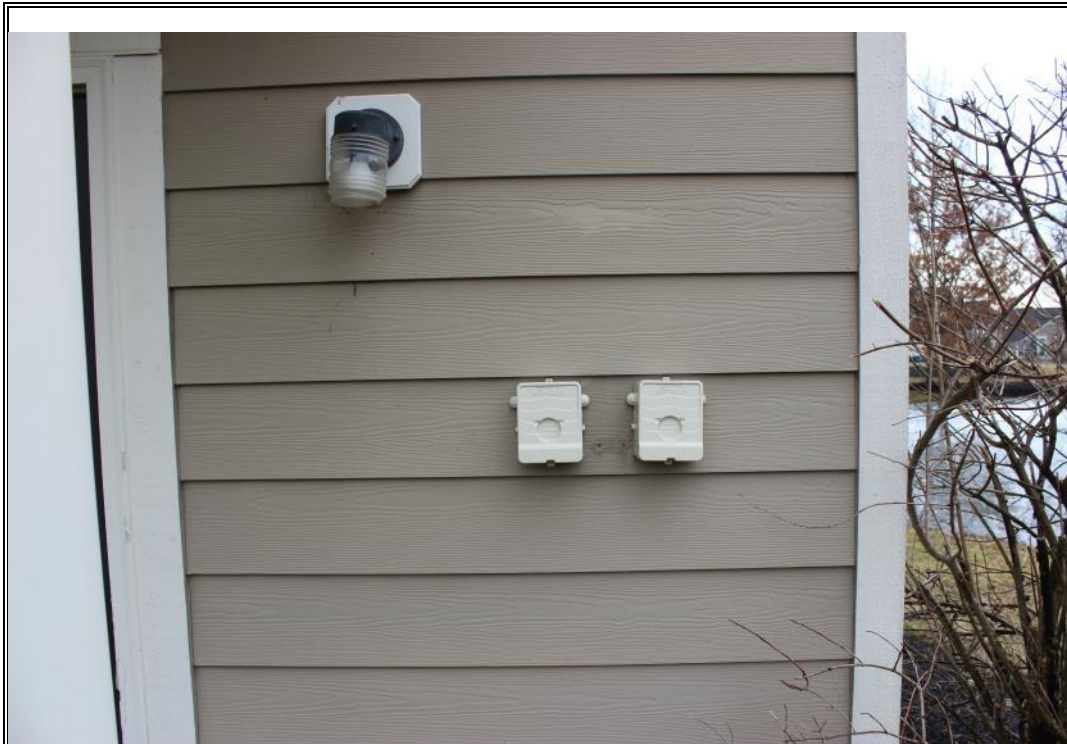
Photo Number
51

Description:
An exterior light on the pump house at pond #6. Note the 2 water meter reading devices.

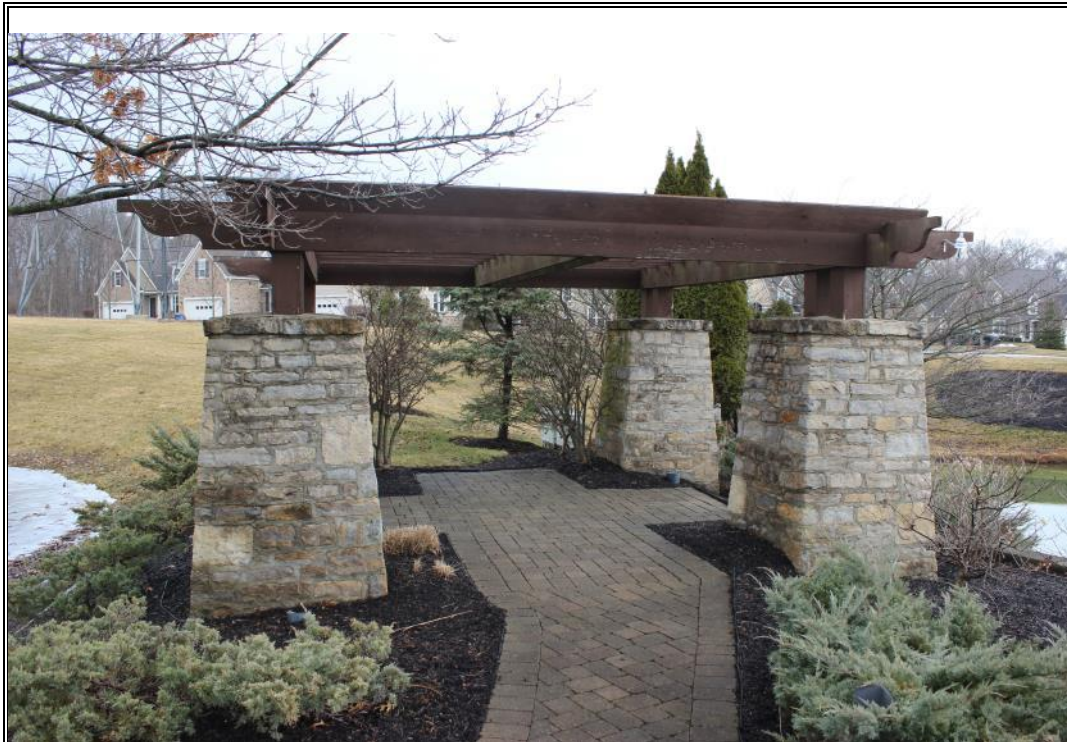
Photo Number
52

Description:
Pergola between ponds #7 and #8. This pergola is in need of recoating.
